TEST REPORT

Report No. : HL30529A/2018

Product Description: M-5 TACTICAL PISTOL LANYARD COILED (KEVLAR)-3.5mm

Test Requested: Pulling Test

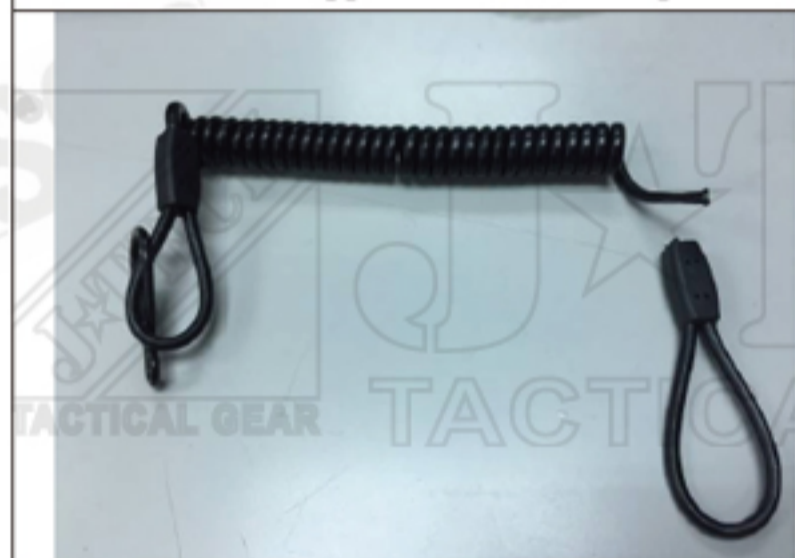
Photo C : After testing

Sample	Max. pulling force (kgf)	Result
M-5 TACTICAL PISTOL LANYARD COILED (KEVLAR)-3.5mm	126.8	The sample was damaged after testing. (As shown on photo C)
