TEST REPORT

Report No. : HL20474A/2017

Product Description: 1 3/4" D-Ring (for Harness use)

Test Requested: Pulling test

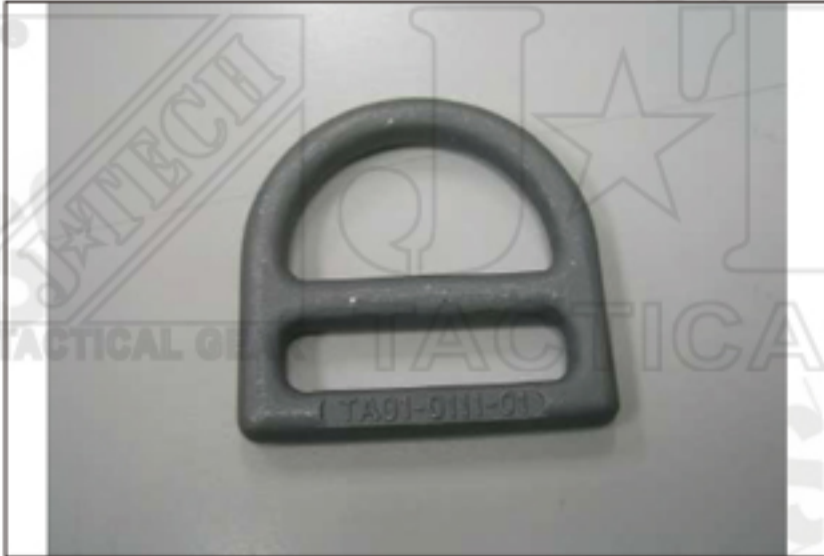
<p>Photo A : Appearance of the sample</p>	<p>Photo B : Test setup</p>

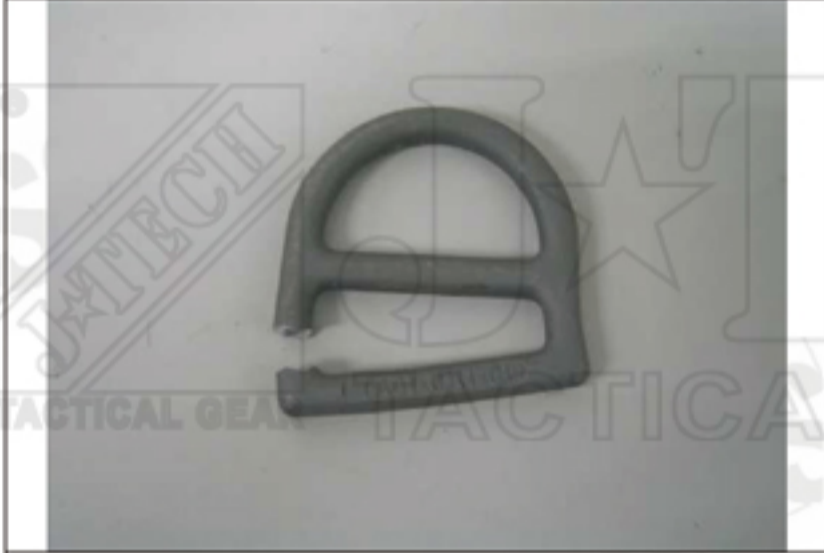
<p>---</p>
<p>Photo C : After testing</p>	<p>---</p>

Sample	Max. force (kgf)	Result
1 3/4" D-Ring (for Harness use)	3509.2	The sample was broken after testing. (As shown in photo C)
